# NGDV – Technical Bulletin

**Title:** Tesa Tape Rework

**Number:** NGDVTB0005

## NGDV Tesa Tape Rework

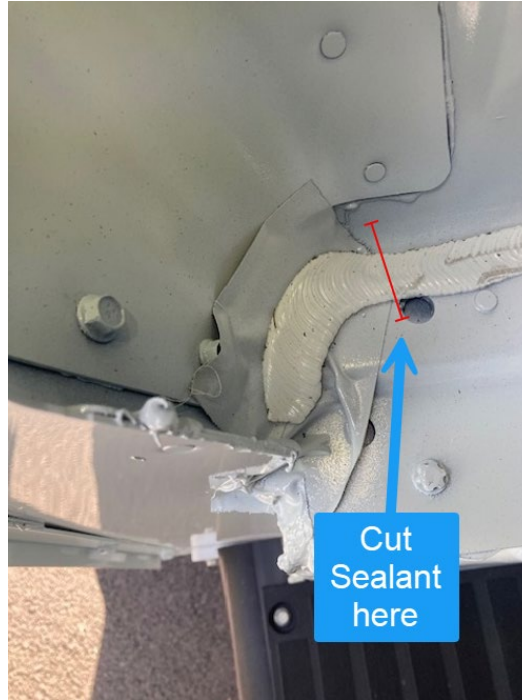
Figure 1

Tape was not fully sealed and connected to the unibody due to excess tape application, causing it to be easily peeled away, allowing dust and water to potentially bypass into the vehicle.

1. Cut seam sealant where it begins to overlap the Tesa Tape (Figure 1).

2. Remove non-conforming, improperly sealed Tesa Tape as shown in figure 1.
