# NGDV – Technical Bulletin

**Title:** Wheel Speed Sensor Faults & Recommended Actions

**Number:** NGDVTB0013

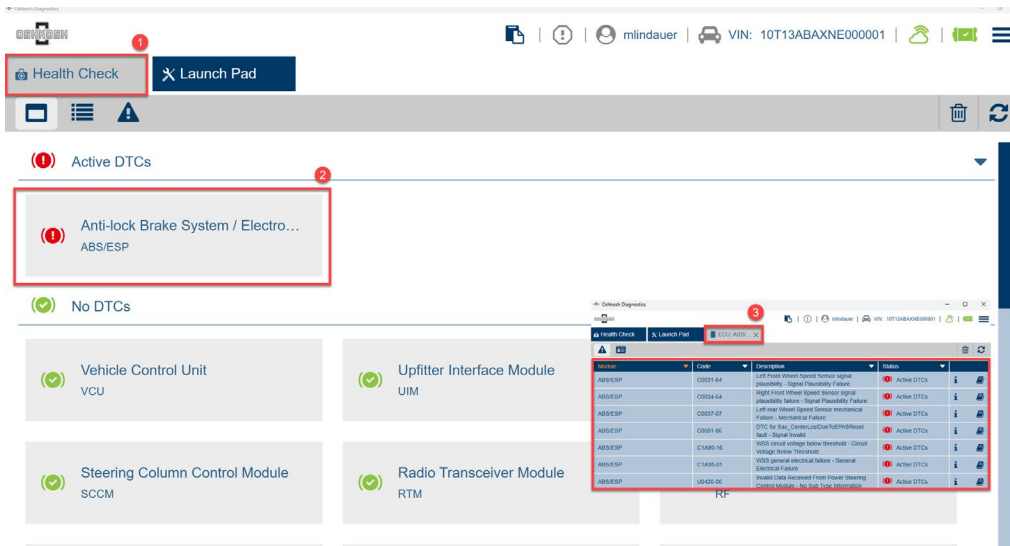
Figure 2

2. Launch OKDT to the page shown in Figure 2. When Health Check (Figure 2, Item 1) completes, select the ABS/ESP module tile (Figure 2, Item 2) on the Health Check menu to view the ABS/ESP DTCs (Figure 2, Item 3).

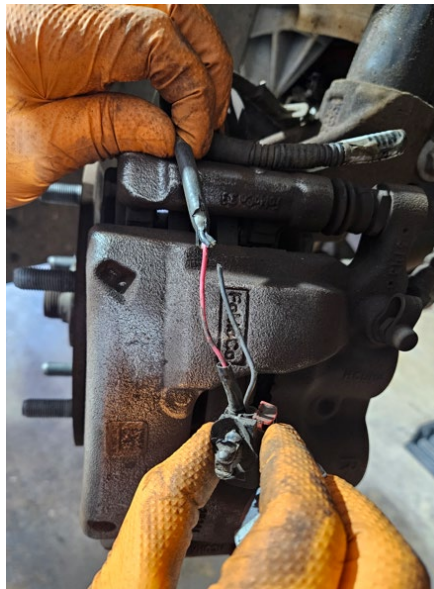
Figure 3

Wheel speed sensor faults may cause damage to the Rear Drive Unit if the vehicle is operated for an extended period of time in a faulted condition. A wheel speed sensor fault can trigger multiple Diagnostic Trouble Codes (DTCs) and tell tales on the instrument cluster. If the repair to the wheel speed sensor harness, DTCs or warning lights go ignored then there is potential for binding within the rear drive unit, especially with full turning angle maneuvers.

4. The wheel speed sensors can be found on the harness that plugs into the wheel end near the brake caliper (Shown in Figure 3).
  - a. For an AWD NGDV, you will find a wheel speed sensor harness on all four wheel ends. You are looking for a damage, or broken wires, as seen in Figure 3, to know if you need to remove and replace the harness that this connector is a part of. Replacing this harness will eliminate your DTCs & Tell Tales and mitigate the possibility of a Rear Drive Unit failure for the specific reasons cited in this Technical Bulletin.

5. If you find one or more of these harnesses broken; please order the applicable harness shown below.

6. Remove and replace the defective harness with the good harness ordered, and submit a claim for the parts and labor involved with this repair.
