# NGDV – Technical Bulletin

**Title:** Spark Plugs

**Number:** NGDVTB0011

## Spark Plugs

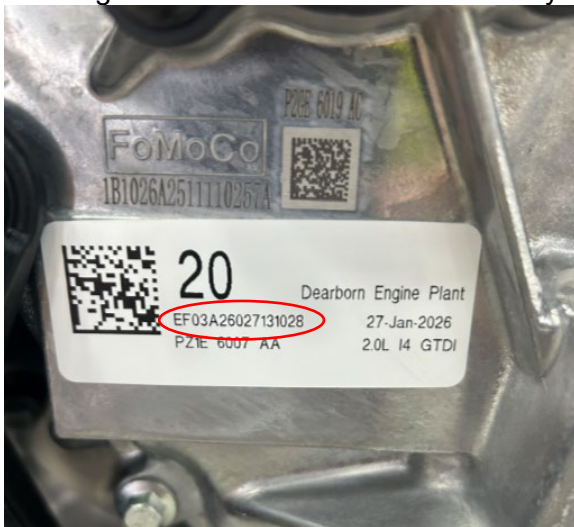
Engine Serial numbers can be found on the front of the engine, near the accessory drive area (belts & pulleys). The engine below was built on the 27<sup>th</sup> day of 2026 or January 27<sup>th</sup>, 2026.

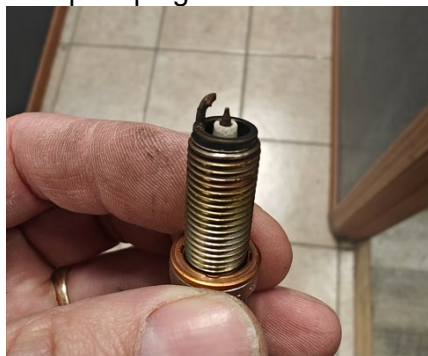
1. If your vehicle is showing DTC's - P0301, P0302, P0303 and/or P0304 set in the powertrain control module (PCM) then remove and inspect the condition of all spark plugs. See page 3-119 in the NGDV Service Manual for instructions on removing and installing spark plugs.
2. If the spark plugs are damaged or melted, replace them with the new spark plug(s) (JYSP-12Y-PTX). See page 3-119 in the NGDV Service Manual for instructions on removing and installing spark plugs.
